<b>Service Bulletin</b>	<b>Revision</b> 001
<b>Warranty:</b> Depends on Install Date	<b>Diagnosing Noise Issues on Sporting Good Elliptical Trainers</b>	<b>Revised Date:</b>
<b>Time Required:</b> 30 minutes	<b>Serial Numbers Affected:</b> All	<b>Prepared by:</b> Kevin Oeltjenbruns

Noise issues arise after installation or after use.

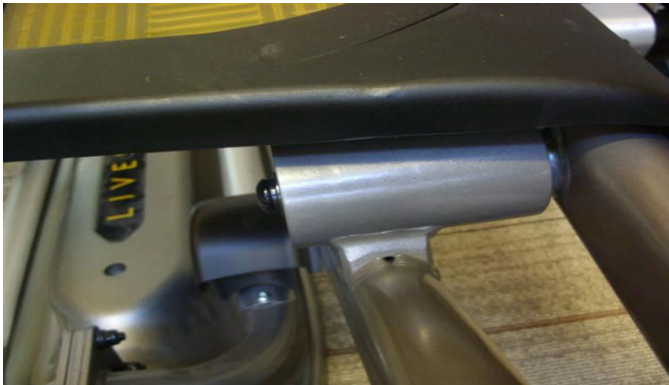
Figure A

1. Check the link arm / pedal arm connection for a loose bolt (Figure A). Lubricate the shaft with lithium based grease (Figure B). This bolt should be torqued to approximately 6 N-m.

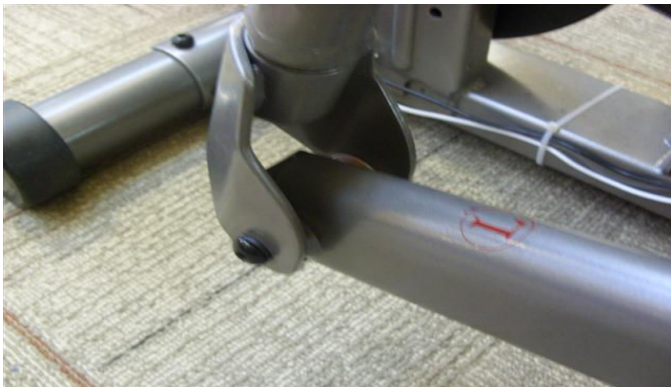
Figure C

2. Check the link arm / handlebar connection for a loose bolt / nut (Figure C). Make sure that there is a Teflon washer on each side of the link arm (Figure D). This bolt should be torqued to approximately 10 N-m.

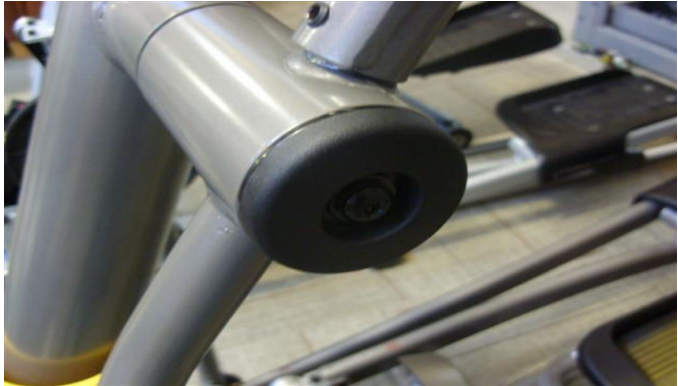
Figure E

3. Check the handlebar / console mast connection for a loose bolt (Figure E). Lubricate the shaft with lithium based grease (Figure F). This bolt should be torqued to approximately 6 N-m.

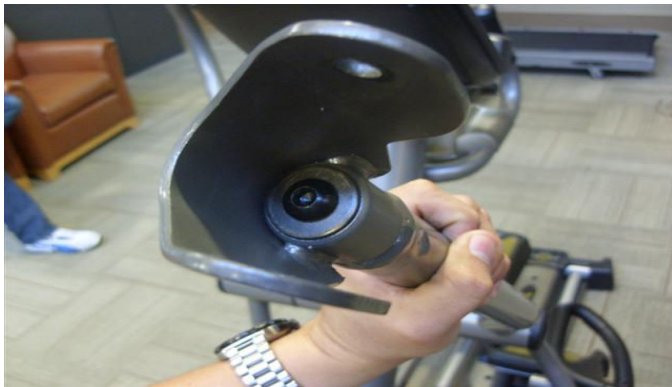
Figure G

4. Check the bolt holding the lower portion of the handlebar to the rest of the handlebar (Figure G). **NOTE:** On some models, this piece will be welded to the rest of the handlebar (like in Figure H), and does not need to be checked. This bolt should be torqued to 6 N-m.

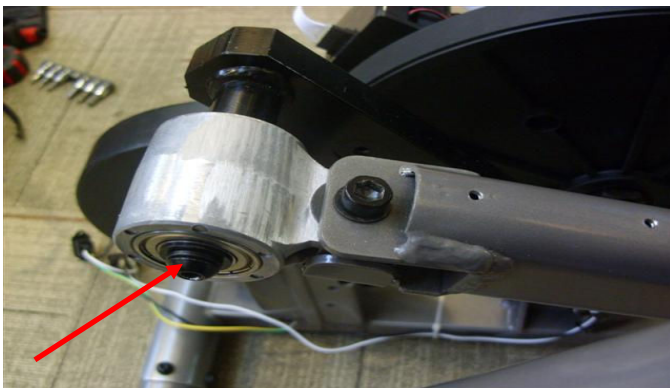
Figure I

5. Check the pivot axle / crank connections for a loose bolt (Figure I). Lubricate the shaft with lithium based grease (Figure J). This bolt should be torqued to 6 N-m.

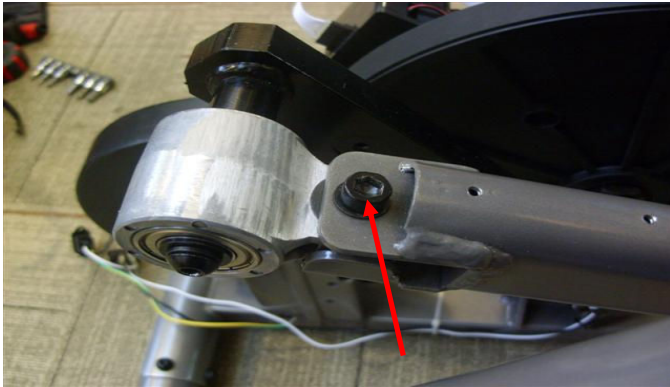
**Figure K**

6. Check the pivot axle / pedal arm connection for a loose bolt / nut (Figure K). This bolt should be torqued to approximately 10 N-m.
7. Check the incline arm / frame connection for loose bolts / nuts (Figure L). These bolts should be torqued to approximately 10 N-m.
